Press Release

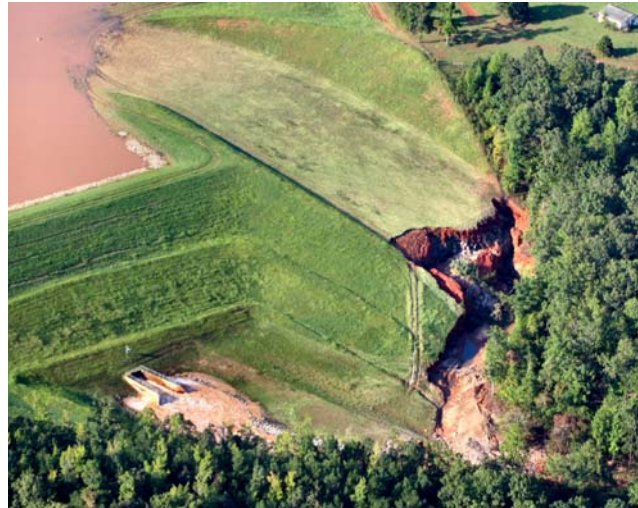
Much of the stormwater runoff from the northern half of the Snake Creek basin, about 2,100,000,000 (2.1 billion) gallons, was absorbed by Lake Seaton as the reservoir's water level increased. After several hours of intense rain, the water overflowed into the emergency spillways which allowed the additional water received by the reservoir to be released over an extended period of time. Emergency spillways are designed to protect a dam by keeping floodwaters from overflowing the dam in severe storm events. As the storm raged on, floodwater flowing through one of Lake Seaton's emergency spillways began eroding the slope downstream of the spillway's control section. A deep erosion cut was formed by the time the storm had ended.

Georgia Safe Dams representatives arrived at the dam early this week and performed a thorough assessment of the site including inspection of the dam, spillways and discharge structures. During their site visit, Safe Dams personnel gave the Authority no directive to lower the water elevation or perform any immediate emergency actions. Safe Dams personnel indicated that any repairs to the eroded slope would need to be designed by qualified engineers. The state would then review and approve the engineering design. A Schnabel representative attending the inspection stated that they are already working on a preliminary design for the repair. The design and repair work should take several months to complete but according to the Schnabel representative there is no threat of the dam failing due to the erosion that occurred at the spillway.
